Manhole Inspection Summary

Manhole # S01EE2012MH

Insp Date: **7/24/06 8:26 AM**

Location Address: **6501 BANCROFT RD**

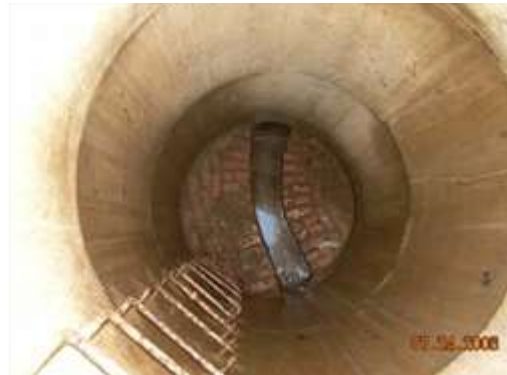
Top View

Adjustment infiltration. Evidence of surcharge - Bench debris. Channel debris.

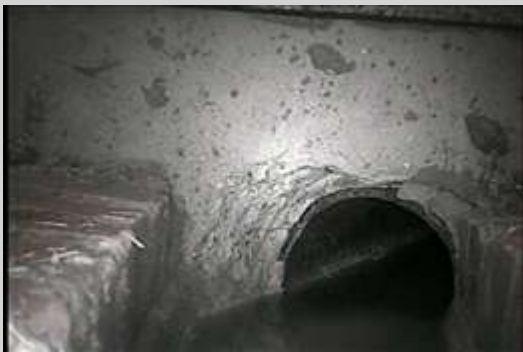
8 in. Circular Gravity Sewer Pipe Out @ 12 O'Clock

Invert Depth: **14.05** (ft.) Flow Characteristics: **Slow**

Infiltration: **Evidence** Pipe Seal Cond: **Unknown**

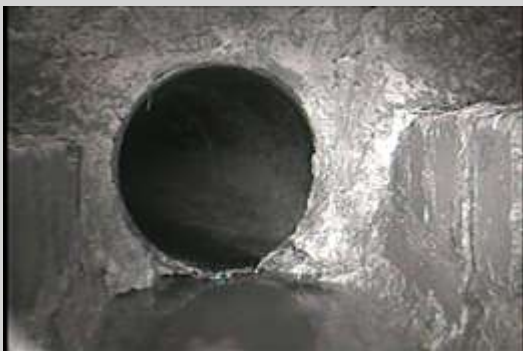
8 in. Circular Gravity Sewer Pipe In @ 5 O'Clock

Invert Depth: **13.85** (ft.) Flow Characteristics: **Slow**

Infiltration: **Evidence** Pipe Seal Cond: **Unknown**
